# Material Analysis of Composite Hollow Core Insulators after one Decade of Observation in Martigues Test Station

A. Baumer<sup>1</sup>, J. Seifert<sup>1</sup>, C. Baer<sup>2</sup>, J. Lambrecht<sup>2</sup>, K. Hindelang<sup>2</sup>

<sup>1</sup> Reinhausen Power Composites GmbH

<sup>2</sup> Wacker Chemie AG

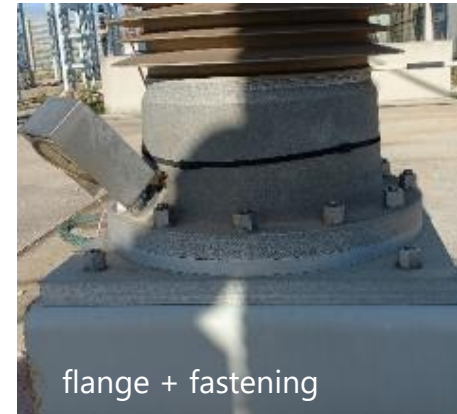
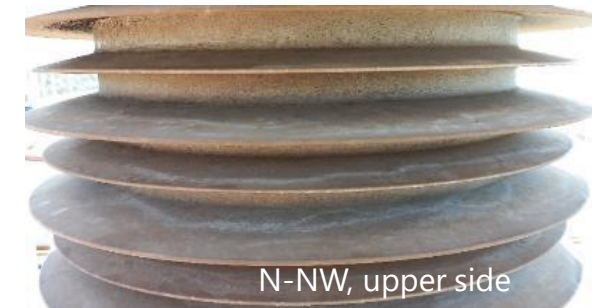
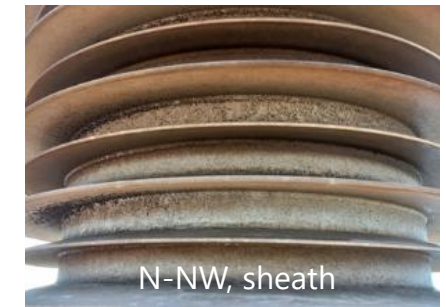
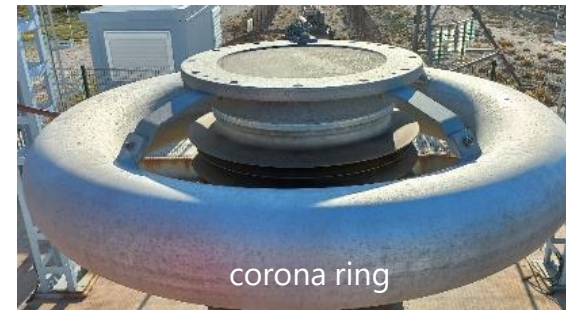
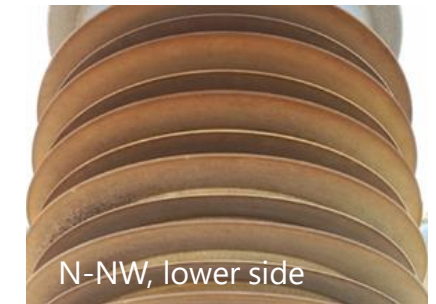
- + Visual inspection
  - Examination from bottom to top (silicone housing, flanges, corona ring, power bracket screws, fastening screws)
  - Point of view: N-NW (industrial pollution), S-SE (marine pollution)
  - Focus on corrosion, erosion, (partial)-discharge induced damages, etc.
    - ⇒ No signs of intense deterioration and wear found
  - Leakage control of N<sub>2</sub> pressurization (3 bar)

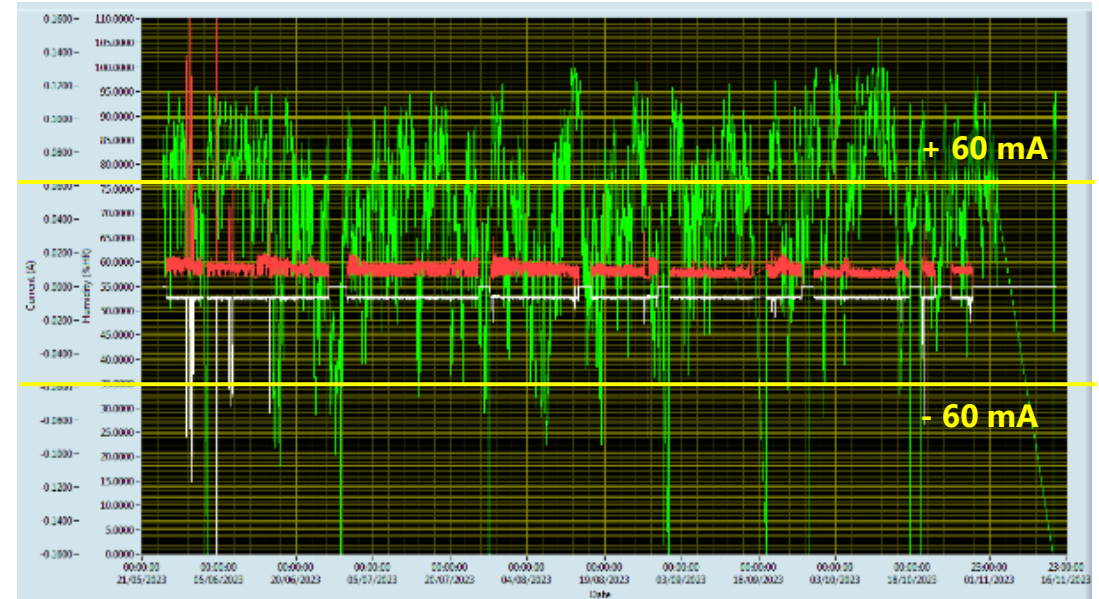
- + Leakage current
  - Continuous measurement
  - Leakage current never exceeded 60 mA (only during a few periods with extreme weather conditions)

Leakage current measurement (red) for the period from 25.05.2023 to 14.11.2023; humidity scale 0 – 110 % (green).

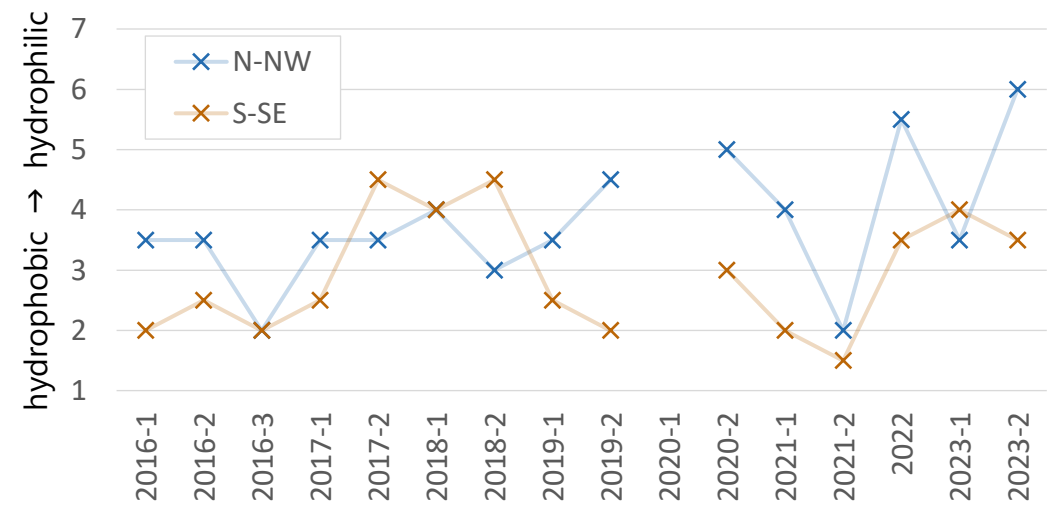
- + Hydrophobicity Test
  - „Spray method“ according to IEC 62073 [6]
  - Evaluation alongside most polluted zones of the insulator: N-NW (towards industrial site), S-SE (towards sea)
  - Determination of wettability class of
    - Upper shed side
    - Lower shed side
    - Shed sheath
  - on three different insulator positions (bottom, middle, top)
  - Diagram shows wettability class of upper shed sides at the top of the insulator.

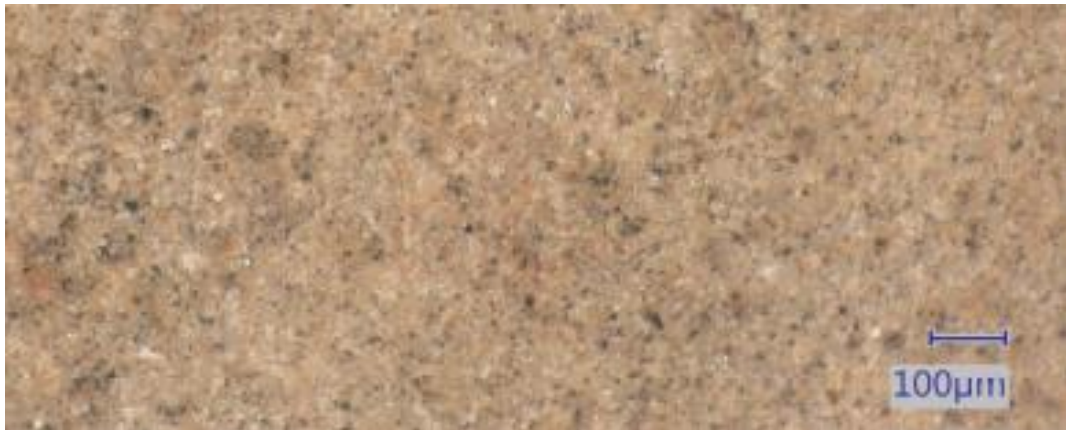
- + Scanning Electron Microscopy (SEM)
  - A rather loose pollution layer that can be removed by cleaning.

Microscopic image of a sample cut from the top side of the insulator with N-NW orientation.

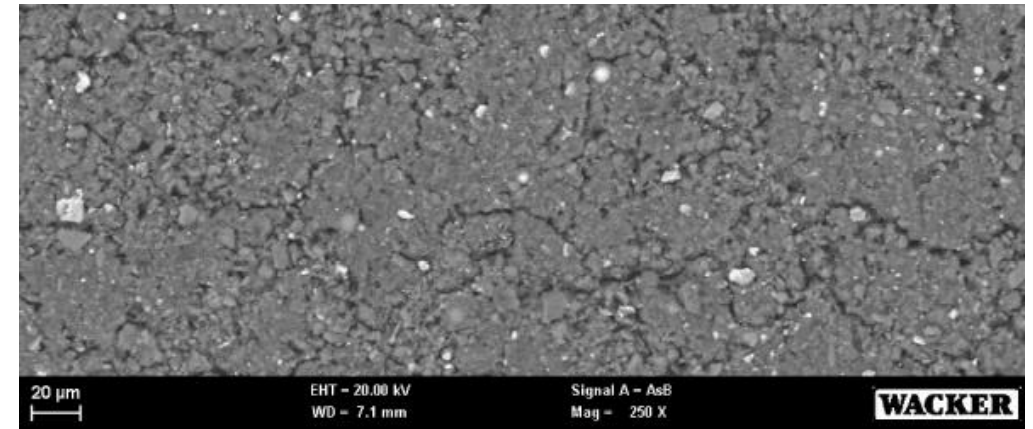
- + Energy-Dispersive X-ray Spectroscopy (EDX)
  - The housing surface was fully intact, no formation of cracks could be found.

SEM image of a sample cut from the top side of the insulator with N-NW orientation.

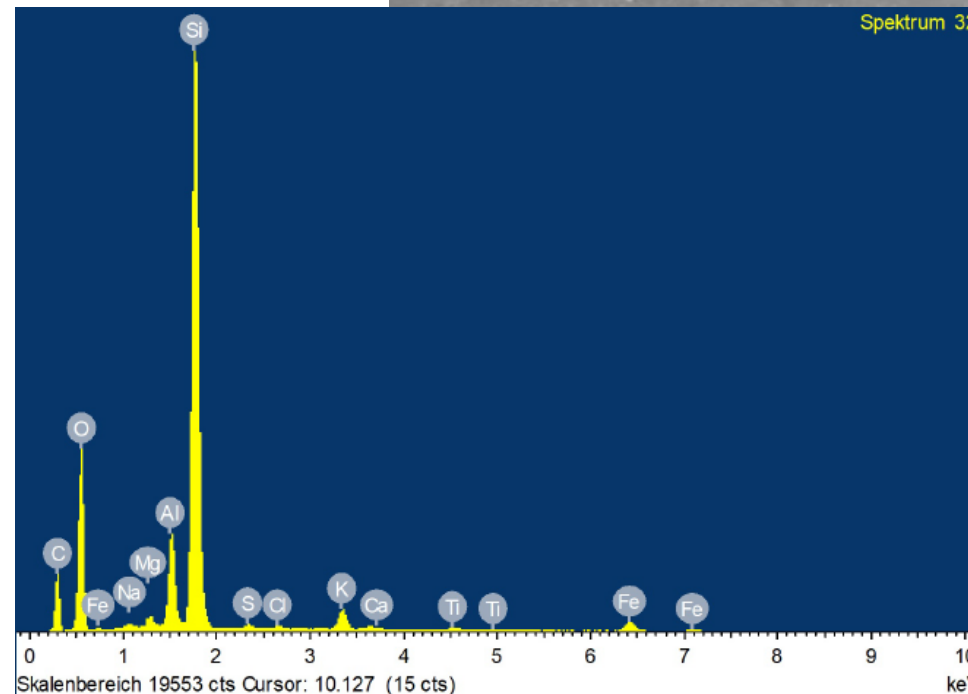
- + Energy-Dispersive X-ray Spectroscopy (EDX)
  - SEM image of a cross-section of a sample cut from the top side of the insulator with N-NW orientation,
  - No formation of hardened silicone layers have been found,
  - Detected chemical elements in the pollution layer are silicon, oxygen, carbon (either from organic pollution or from silicone polymer) as well as aluminium, iron, calcium, potassium, sodium, magnesium originating from the surrounding environment and industry area.

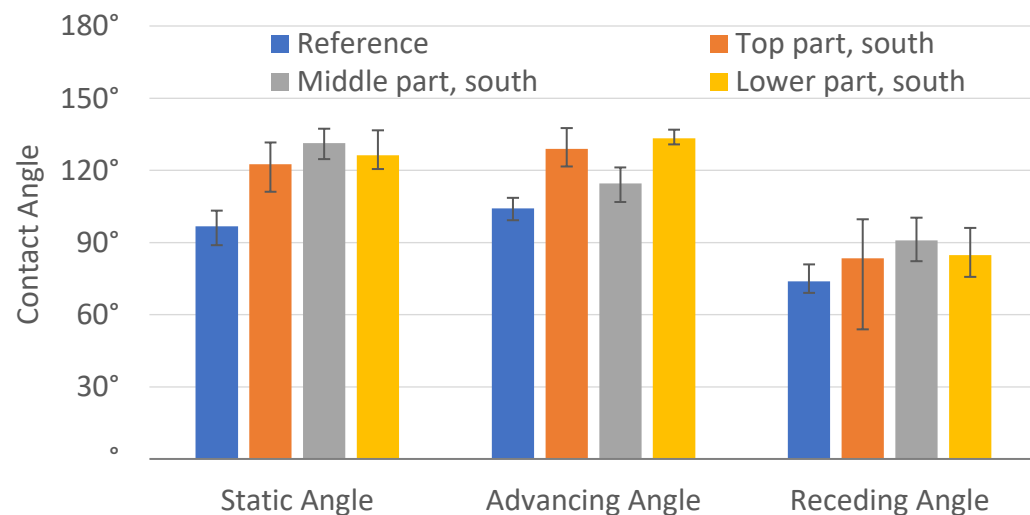
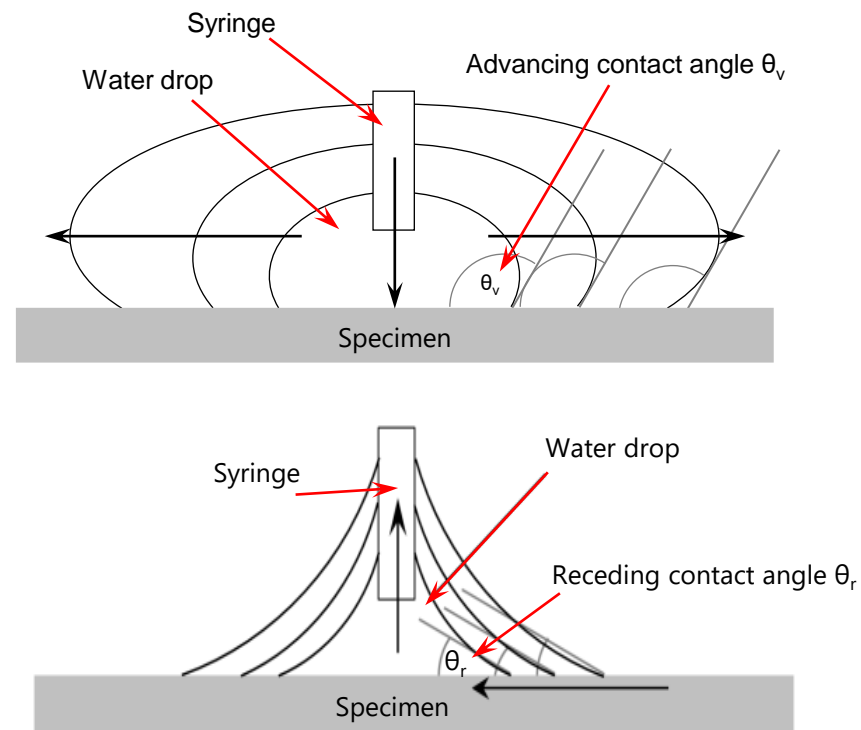
- + Hydrophobicity measurement
  - Determination of static and dynamic (advancing and receding contact angles) [8]
  - Usage of an automated goniometer
  - Measured values can be correlated to hydrophobicity class 1 – 2 (according to IEC TR 62073) [6]

⇒ Difference to hydrophobicity measurement on site at Martigues might be caused by a hydrophobicity transfer over the storage time of the samples after dismantling.

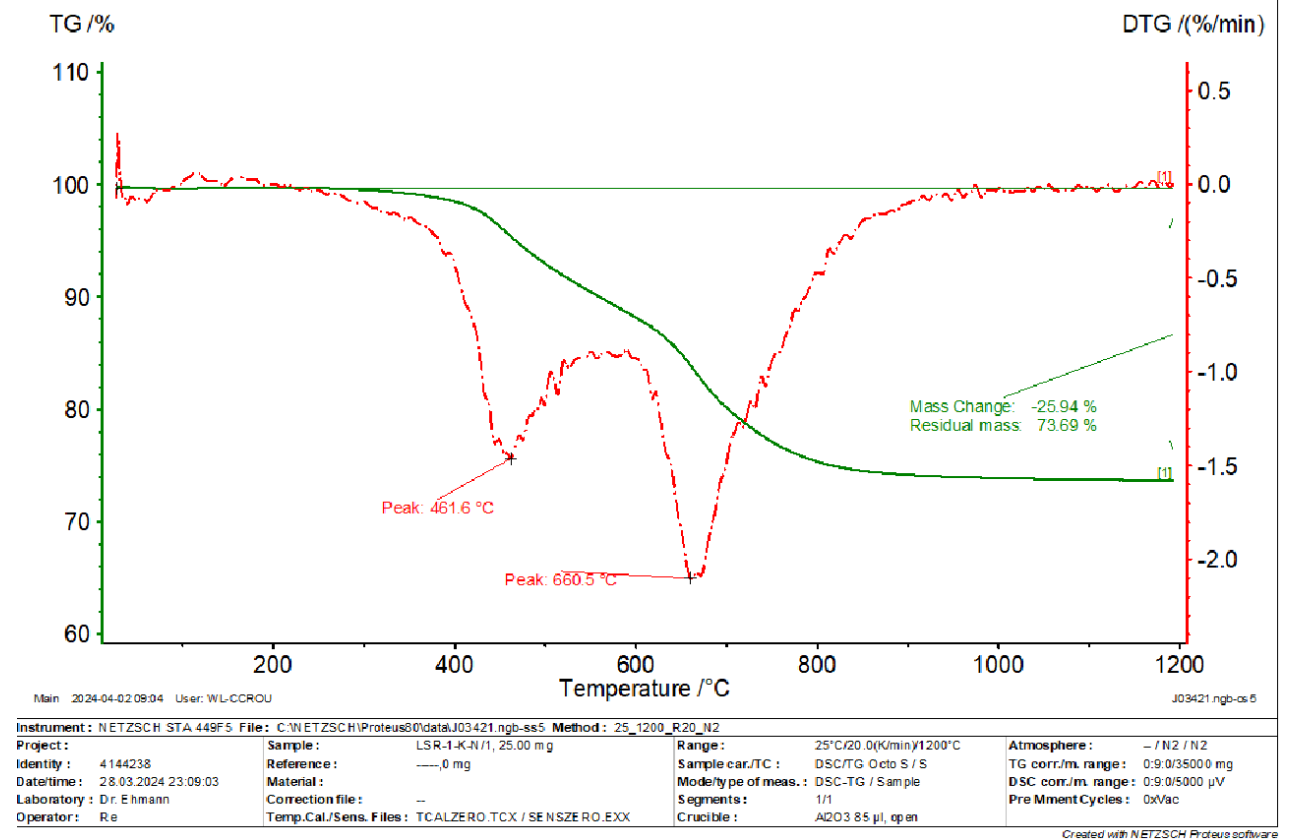
- + Thermogravimetric Analysis (TGA)
  - Diagram shows mass loss during TGA from 20 °C to 1.200 °C (reference & top shed, N-NW orientation)
  - Thermal material decomposition from about 250 °C up to 800 °C, mass loss approx. 25 %

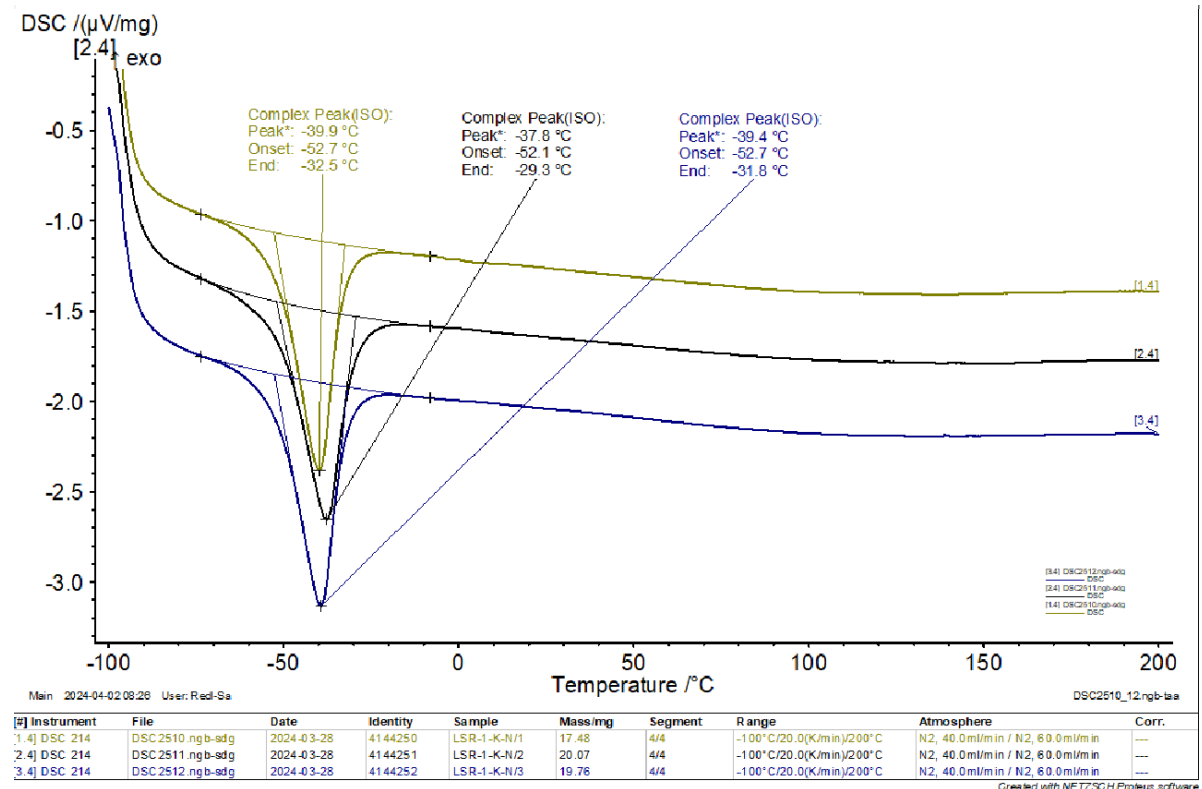
- + Differential Scanning Calorimetry (DSC)
  - Diagram shows DSC for three samples from -100 °C to 200 °C (reference & top shed, N-NW orientation)
