# Material Analysis of Composite Hollow Core Insulators after one Decade of Observation in Martigues Test Station

A. Baumer<sup>1</sup>, J. Seifert<sup>1</sup>, C. Baer<sup>2</sup>, J. Lambrecht<sup>2</sup>, K. Hindelang<sup>2</sup>

<sup>1</sup> Reinhausen Power Composites GmbH

<sup>2</sup> Wacker Chemie AG

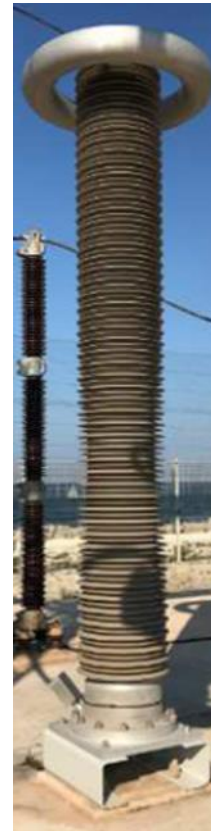
### Composite hollow core insulator with LSR housing

Voltage class	420 kV
Housing material	POWERSIL® XLR® 630
Average diameter	475,5 mm
Diameter corr. factor	1,09
Total creepage distance	14.490 mm
Creepage factor	4
Specific creepage distance, corrected	37,6 mm/kV
Ratio shed overhang to shed spacing	1,07
Profile	Alternating
Rated voltage	245 kV AC

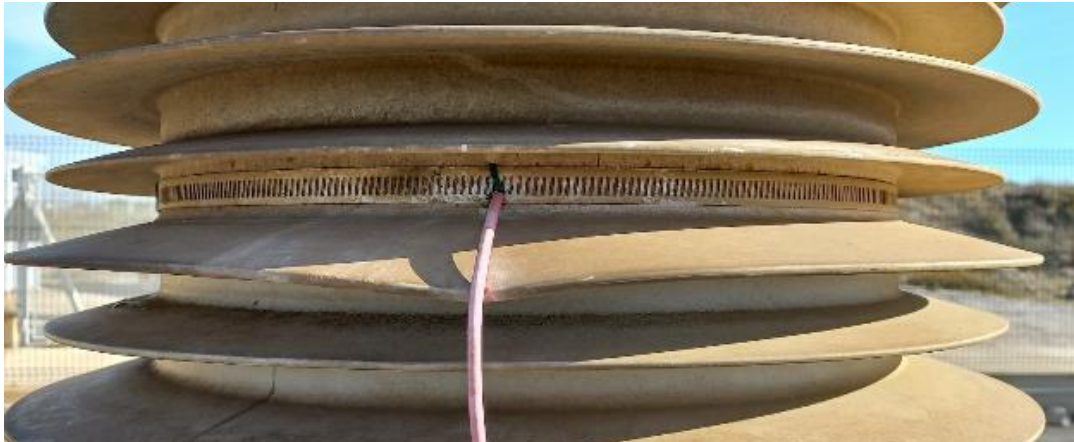
Leakage current measuring collar

- + Leakage current
  - Continuous measurement
  - Leakage current never exceeded 60 mA (only during a few periods with extreme weather conditions)

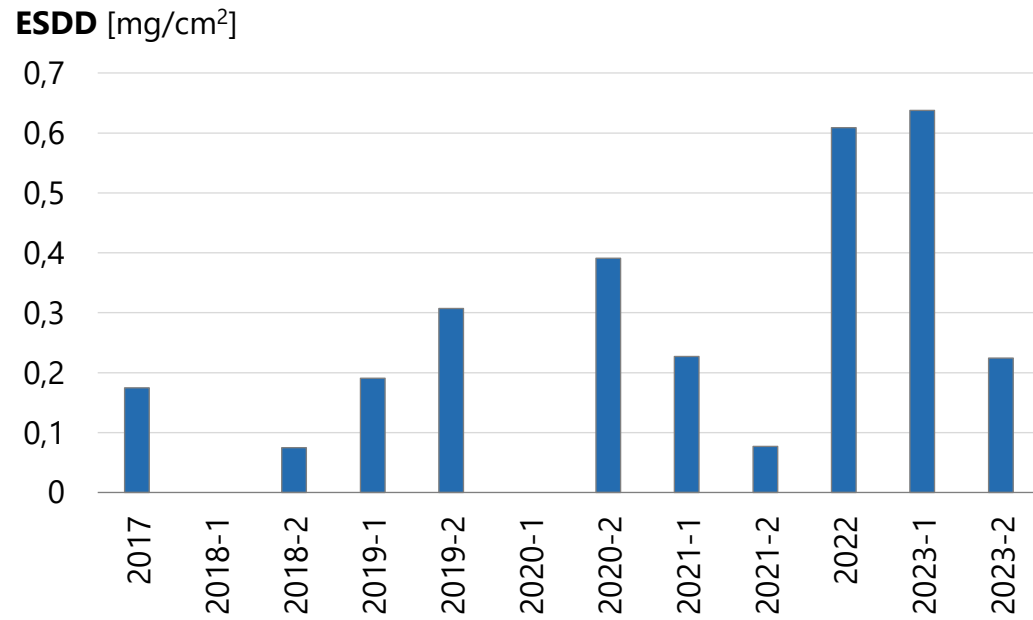
- + Pollution Analysis  
Equivalent salt deposit density (ESDD) according to IEC 60815-1:2008 [5]

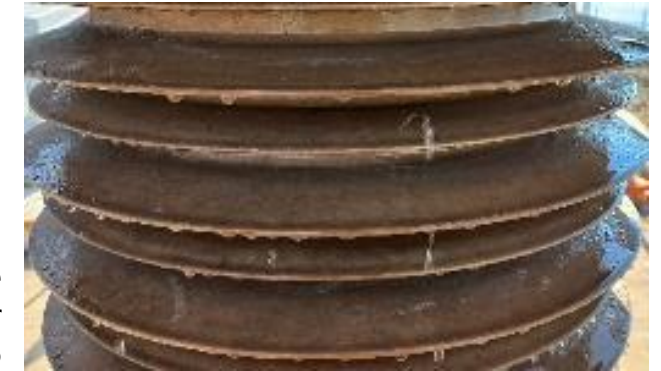
- + Hydrophobicity Test
  - „Spray method“ according to IEC 62073 [6]
  - Evaluation alongside most polluted zones of the insulator: N-NW (towards industrial site), S-SE (towards sea)
  - Determination of wettability class of
    - Upper shed side
    - Lower shed side
    - Shed sheath
  - on three different insulator positions (bottom, middle, top)
  - Diagram shows wettability class of upper shed sides at the top of the insulator.
